COMPARISON OF PV MODULE PERFORMANCE BEFORE AND AFTER 11 AND 20 YEARS OF FIELD EXPOSURE

ABSTRACT

In 1990 the Schatz Energy Research Center (SERC) installed a PV array comprised of 192 ARCO M-75 modules. Prior to installation, SERC measured the performance of each module. For the past 20 years the array has continued to operate in a cool, marine environment. The performance of each module was re-evaluated in 2001 and again last year in 2010.

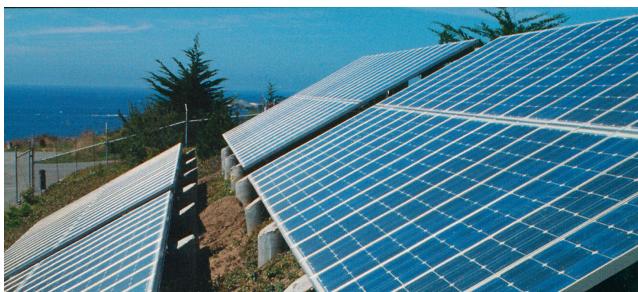
Figure 1: The SERC 192-module PV array installed at HSU's Telonicher Marine Lab; the Pacific Ocean is in the distance. The photo was taken in 1990 when the array was new.

In 1990 SERC installed a nominal 9.2 kW_p photovoltaic (PV) array (Figure 1) at Humboldt State University's (HSU) Telonicher Marine Laboratory in Trinidad, CA. The array is situated approximately 150 meters from the ocean in a cool, coastal environment. The PV system is an integral part of an ongoing solar hydrogen demonstration project and its primary function is to power an air compressor for HSU's marine laboratory. Excess power produced by the array is shunted to a Teledyne Energy Altus 20 electrolyzer in order to produce hydrogen fuel for a proton exchange membrane (PEM) fuel cell.

The SERC PV array consists of 192 photovoltaic modules configured into 12 independent subarrays facing due south and tilted at 30° from the horizontal. Each subarray consists of 16 modules wired in 8 series pairs for operation at 24 VDC. All modules were originally ARCO M-75s; since installation three have been replaced due to

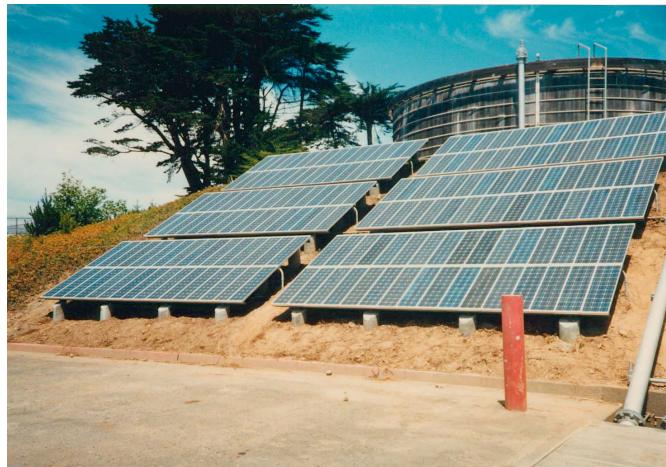
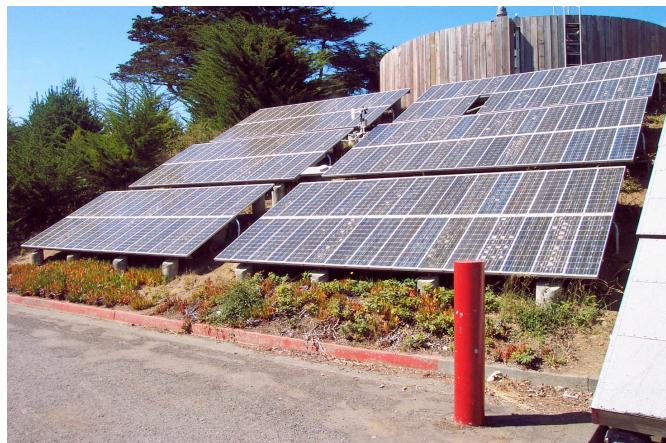
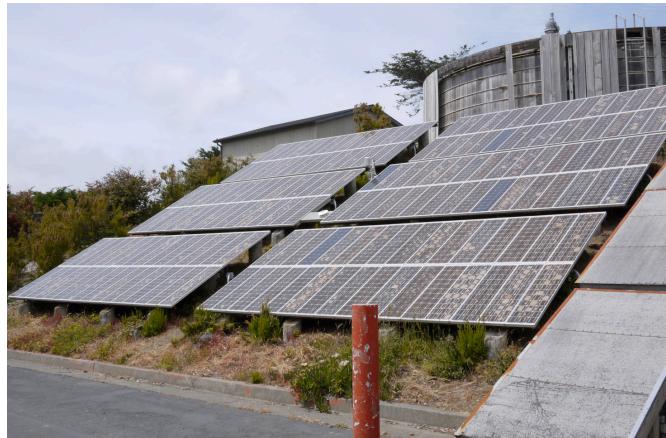
Figure 3: Trinidad Array in 1990 (top), 2001 (center), and 2011 (bottom)

When the modules were originally installed in 1990 the individual cells in these modules ranged in color from a light aqua blue to a deep dark blue (Figures 1 & 3, top). After 11 years of field use, EVA browning was observed to some degree on all of the modules. The discoloration ranged from a light yellow color to a dark brown and occurred directly over the cell surface (Figure 3, center). By 2010 after 20 years of exposure, the discoloration has become even more severe and widespread (Figure 3, bottom). The EVA above the edges of the cells was lighter in color and the diamond shaped areas in between the corners of cells was clear (Figure 4). This pattern of discoloration has been reported by others and attributed to photo-oxidative bleaching (Czanderna and Pern [3]; Dhere and Raravikar [4]). The primary effect of EVA browning is a reduction in the amount of light energy reaching the Si-cell surface, which causes a decrease in current generation, as reported by Czanderna and Pern [3].

Delamination was observed on the majority of the cells in modules located in the array. In all cases, the delamination occurred on the EVA/silicon interface (see Figure 3 and Figure 5). The delamination was present most frequently on and around the buslines and the cells had become completely unbonded from the silicon, buslines and metallization grid. The delamination is assumed to originate along the busline and metallization grid due to the fact that these segments are raised slightly above the silicon cell, providing a preferential location for reduced adhesive strength of the encapsulant. These sites also provide void spaces for moisture accumulation.
